Action Discovery Report

Lower White River Watershed, HUC 05120202
Upper White River Watershed, HUC 05120201

Discovery Appendix

Mitigation Needs Assessment for the Lower and Upper White River Watershed, Indiana

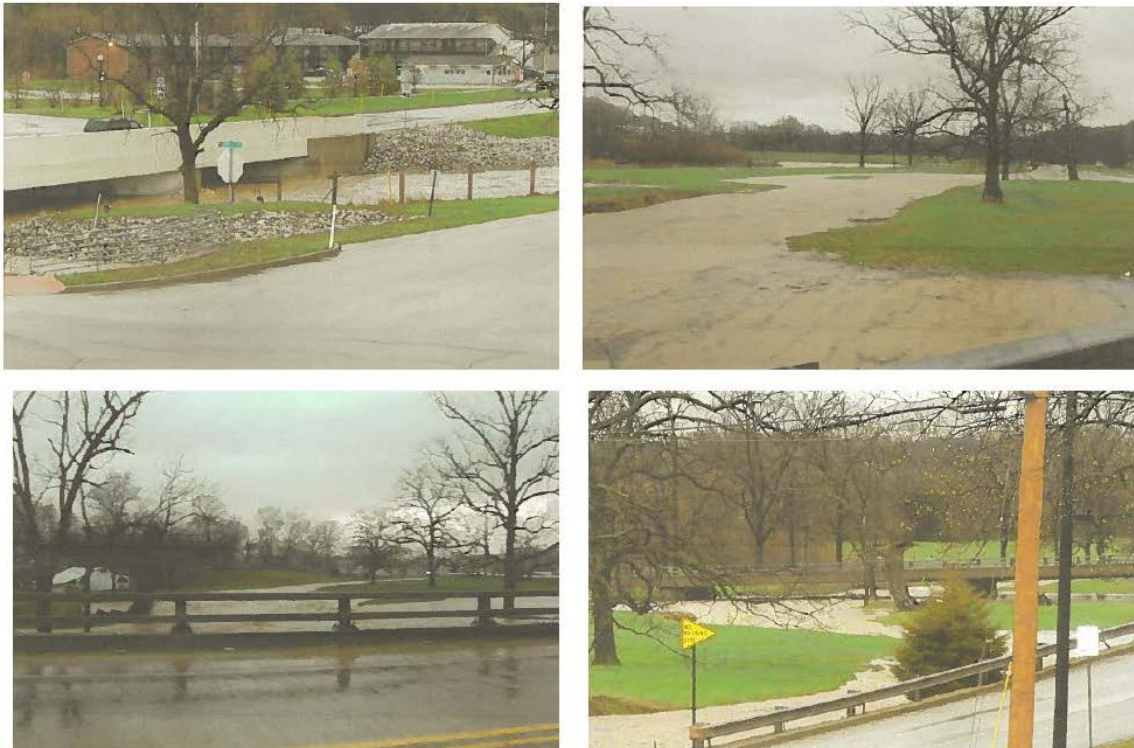
Figure 4. April 2011 Temperance Street Town Property

Flooding has affected the intersection at State Road 46 or East Temperance Street and Park Street for many years. The community relocated emergency services from the building adjacent to the tributary. Currently the town manages the street department out of this facility.

- Evaluate alternatives at the Town property at East Temperance Street to determine if detention in this area would affect flood elevations through town. Also review the drainage at the culverts along Turtleback Creek to determine if mitigation efforts are needed.
- Evaluate alternatives at the Main Street Bridge to determine if additional conveyance at the bridge would affect flood elevations through town.
- Evaluate alternatives at McNeely Street to determine if detention or modifications to the McNeely Street bridge would affect flood elevations in the general area of McNeely Street, and/or upstream through town.

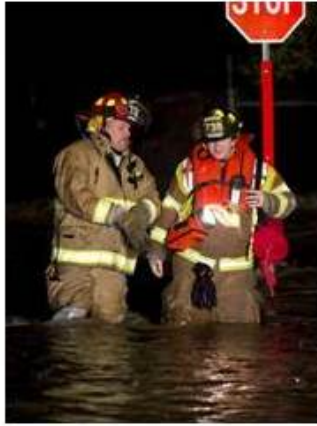
Figure 9. December 2013 Flooding at Main and Sale

The Town Hall located along Sale Street was subjected to three bouts of flooding within the last five years. A discussion on how to mitigate this issue occurred following flooding at Town Hall in December 2013. The Town investigated the option of obtaining flood insurance to avoid relocation costs; however, since the structure is considered commercial, the rates were actuarial and therefore very costly. It made

more fiscal sense to relocate the Town Hall versus obtaining flood insurance. The council authorized the move for \$50,000, but the action cost was only \$10,000.

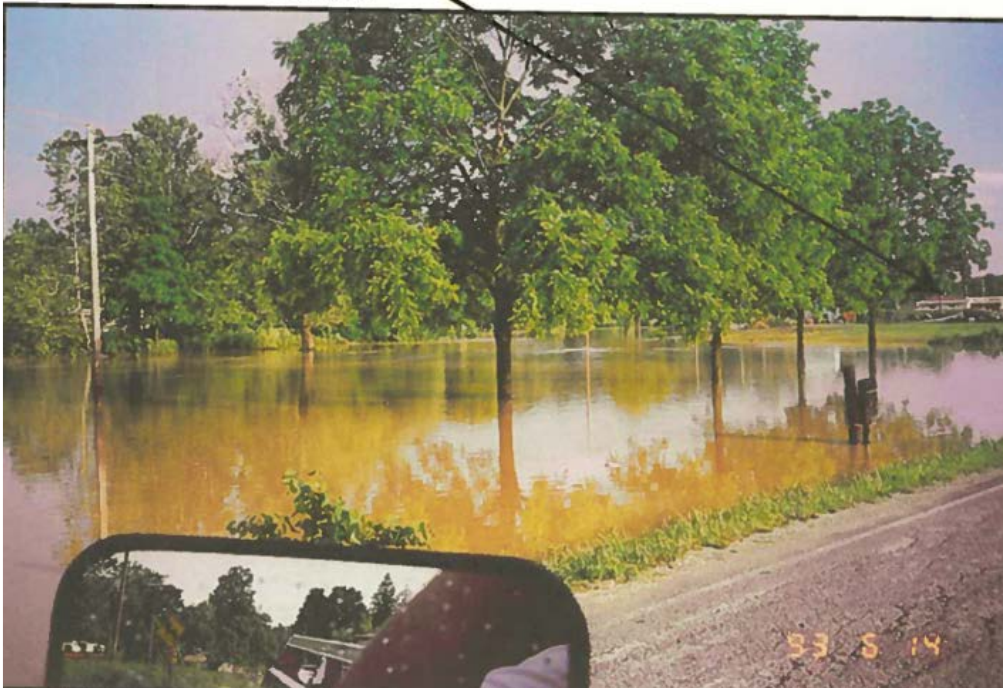
Figure 16. June 1993 Chads Recycling & Refuse

Image shows Chad's Recycling and Refuse, LLC
Flood June 14, 1993
Photos Provided by Ellettsville Street Department

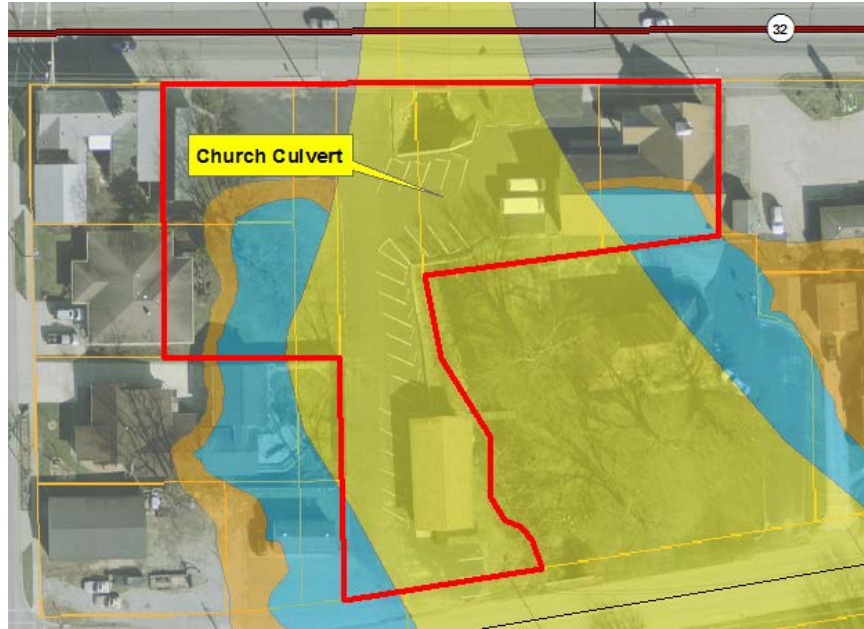
Figure 21. Church Parking Lot Culvert

There are two bridges located near the church parking lot; the State Road 32 Bridge and the parking lot that exists over the stream crossing. The culvert for the parking lot is undersized and is believed to be the reason the properties along Mill Creek Drive are at risk of flooding.

- Using the existing FIS model, evaluate alternatives at the Church culvert to determine if removing the structure in this area would affect flood elevations along Mill Creek Drive, and/or upstream near Mulberry Drive.
- Evaluate alternatives at the Railroad culverts to determine if enlarging the structure in this area would affect flood elevations upstream of State Road 67.
- Explore the potential of using the gravel pit as a detention basin. Determine if the town and the private landowner could develop an agreement about the site or determine if the parcel could be divided and portions of the property turned over to the Town.
- Investigate areas upstream of Mulberry Drive and determine impacts to flood elevations.

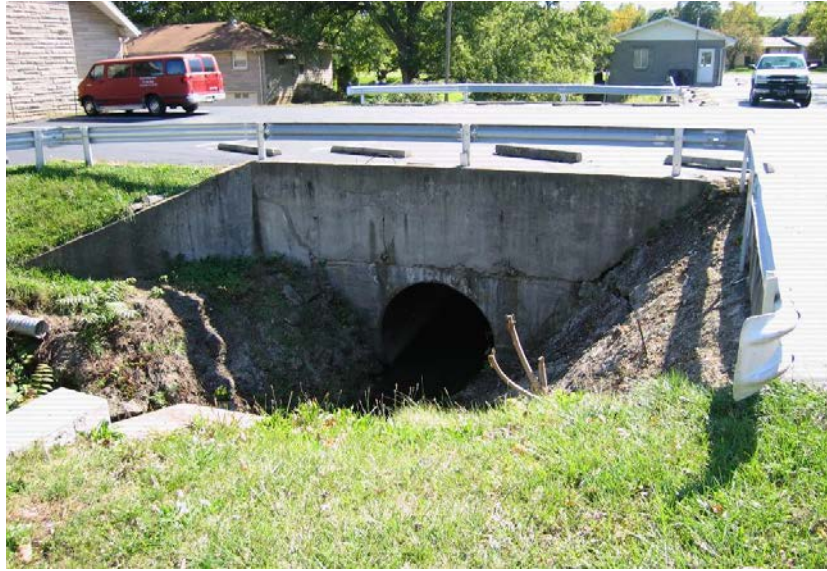
Figure 23. Church Culvert

The parking lot is owned by the Parkview Wesleyan Church, and it was discussed that there is a possibility that the church would turn over a portion of the property to the town. It is believed removing the culvert crossing would cause flood elevations to drop dramatically, reducing the flooding risk to Mill Creek Drive residents.

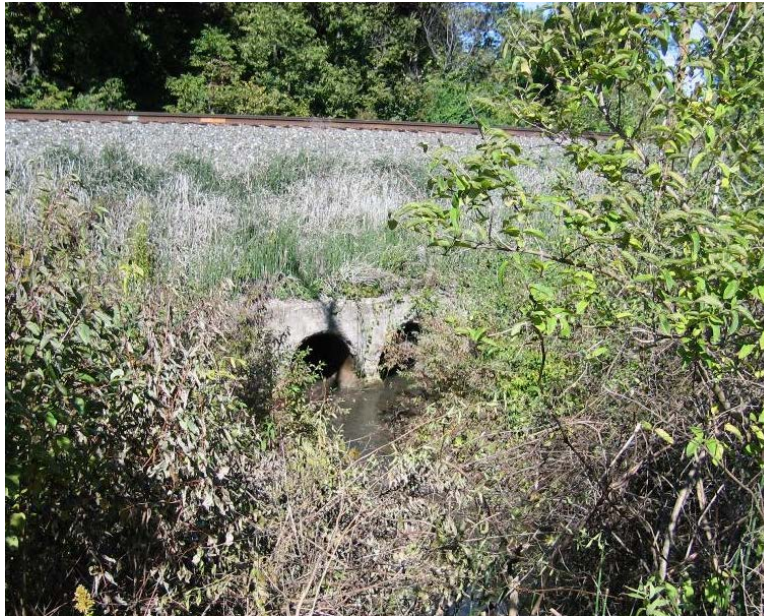
Figure 24. Railroad Culverts

The Mulberry Drive Neighborhood is mapped in the Special Flood Hazard Area Zone AE/Floodway. It is believed that the neighborhood is at a high-risk of flooding because of the insufficient size of the culverts beneath the Railroad just downstream of the State Road 67 Bridge. As can be seen in Figure 24, there are two small culverts for the railroad crossing. With the Physical Map Revision in 2014, the mapping in the Mulberry Drive neighborhood area was mapped as storage behind the railroad culverts.

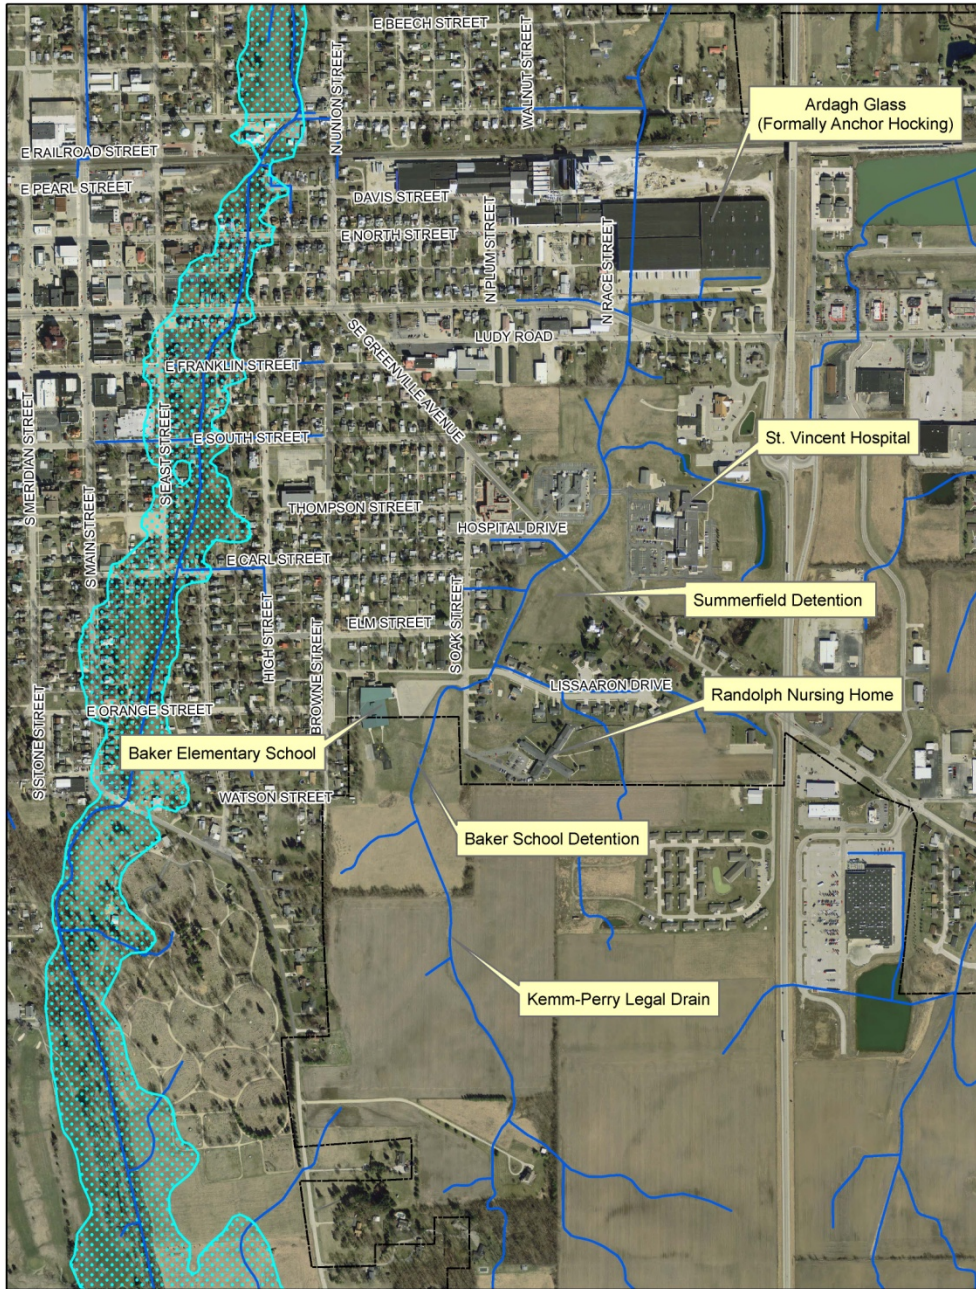
Figure 27. Kemm-Perry Legal Drain and Baker School

Much of the flooding in Winchester comes from the Kemm-Perry Legal Drain that runs from south to north in the eastern half of Winchester. The legal drain takes on drainage from several acres of farm field to the south and continues north between Baker Elementary School and the Randolph Nursing Home. Kemm-Perry continues north through culverts beneath Lissaaron Drive and S Greenville Avenue through the St. Vincent Hospital property (west of the hospital building). Kemm-Perry eventually crosses under State Road 32 and travels beneath Ardagh Glass resurfacing beneath the railroad south of Short Street.

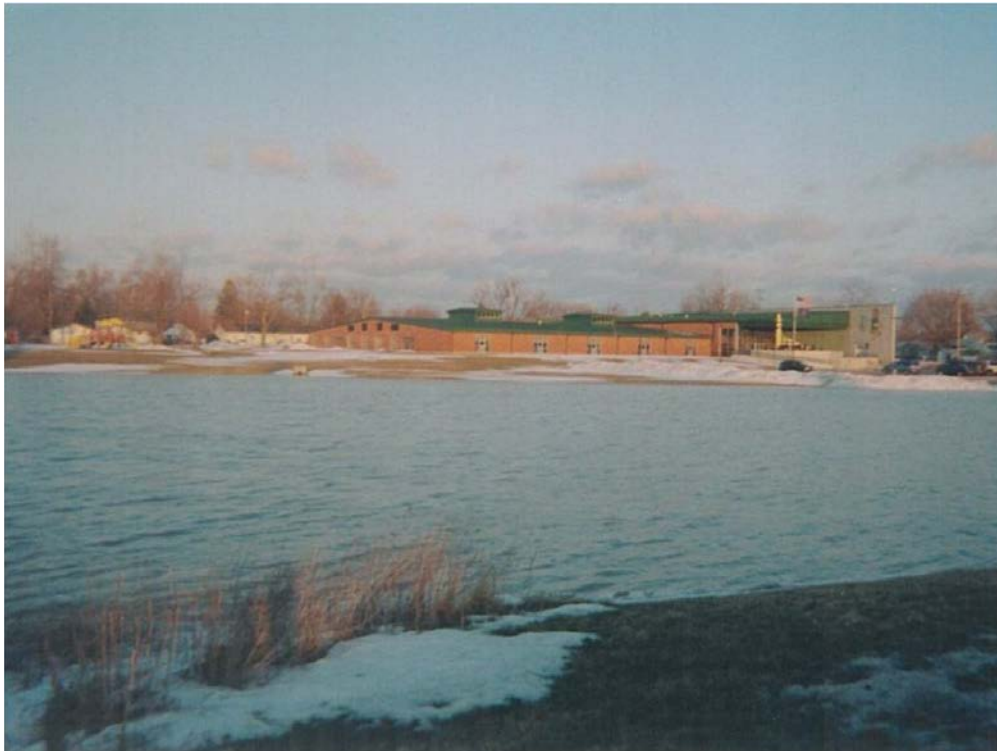
Figure 28. 2008 Flooding a Baker Elementary School

During severe rain events the Baker Elementary School property experienced flooding and on occasion, the flooding overtopped roads in the vicinity. The following images were taken in January 23, 2008 by Chris Martin, City of Winchester Wastewater Superintendent.

Baker Elementary School drainage improvements involved installing a 30 inch drainage pipe from the drainage basin at Baker Elementary School into the Summerfield Detention basin. The work for this project was completed in March of 2009. The pipe runs from the north side of Baker Elementary School detention basin beneath East Oak Street and Lissaaron Drive to the south end of Summerfield Detention basin.

In addition, an engineering plan was created and implemented to enlarge Summerfield Detention basin to ensure that the basin can handle the increased volume of water from Baker Elementary School Detention basin. The work was started after the installation of the drainage pipe and completed in 2009.

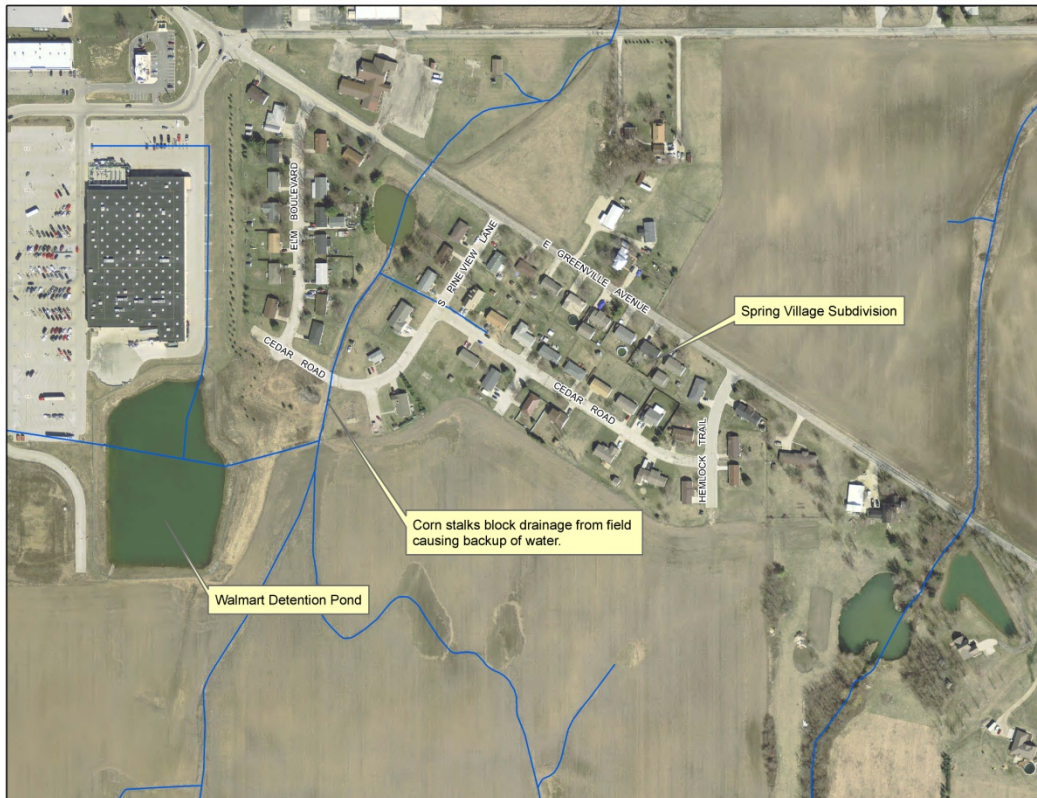
Figure 33. Spring Village

The Spring Village subdivision is located in southeast Winchester. This subdivision receives drainage from an Unnamed Tributary to Peach Creek located in the farm field to the south. The drainage enters the subdivision through a culvert beneath Cedar Road. In heavy rain events, corn stalks will block the entrance to the culverts causing flooding in the field, subdivisions and across the road. Flooding events have decreased in frequency since the development of Walmart's detention pond.

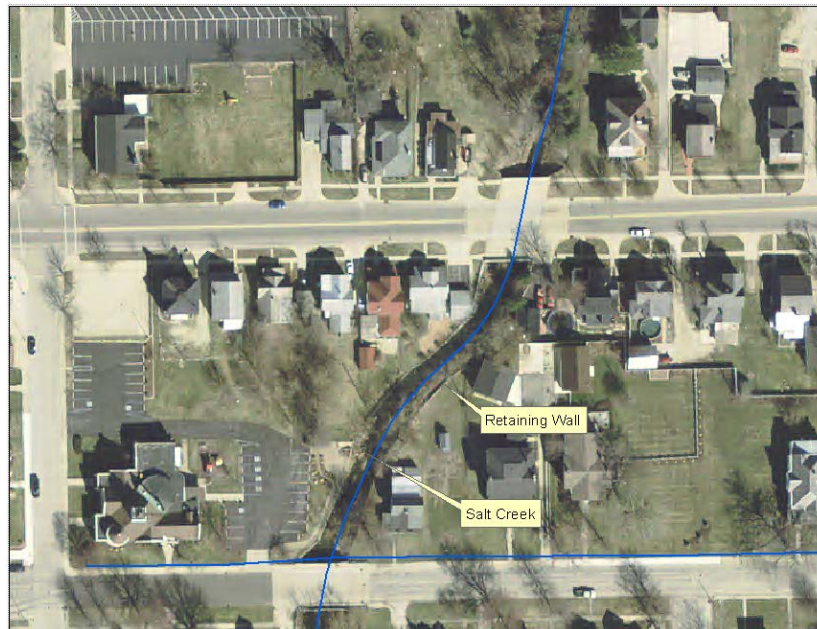
Figure 35. Salt Creek Retaining Walls

There are several retaining walls (locally referred to as seawalls) built on land along Salt Creek on both privately and publically owned land. The City has been contacted by land owners, whose seawalls have fallen in disrepair, asking the City to rebuild them. There was some discussion of liability and whether these have any impact on base flood elevations or if these seawalls were considered when the mapping was done.

- An evaluation of the culvert under Ardagh Glass with recommendations for any mitigation measures that may be needed.
- An evaluation of the retaining walls along Salt Creek with recommendations for any mitigation measures.
- An overall evaluation of the flooding threats within the City of Winchester with recommendations for any mitigation measures.
- An evaluation of the Hydrologic and Hydraulic studies with a recommendation on the updating of the Flood Insurance Rate Maps based on the study (and possibly any mitigation measures).

In addition, recommendations regarding the retaining walls along Salt Creek will allow the city to properly address the condition of these features to best mitigate flooding impacts along the creek.

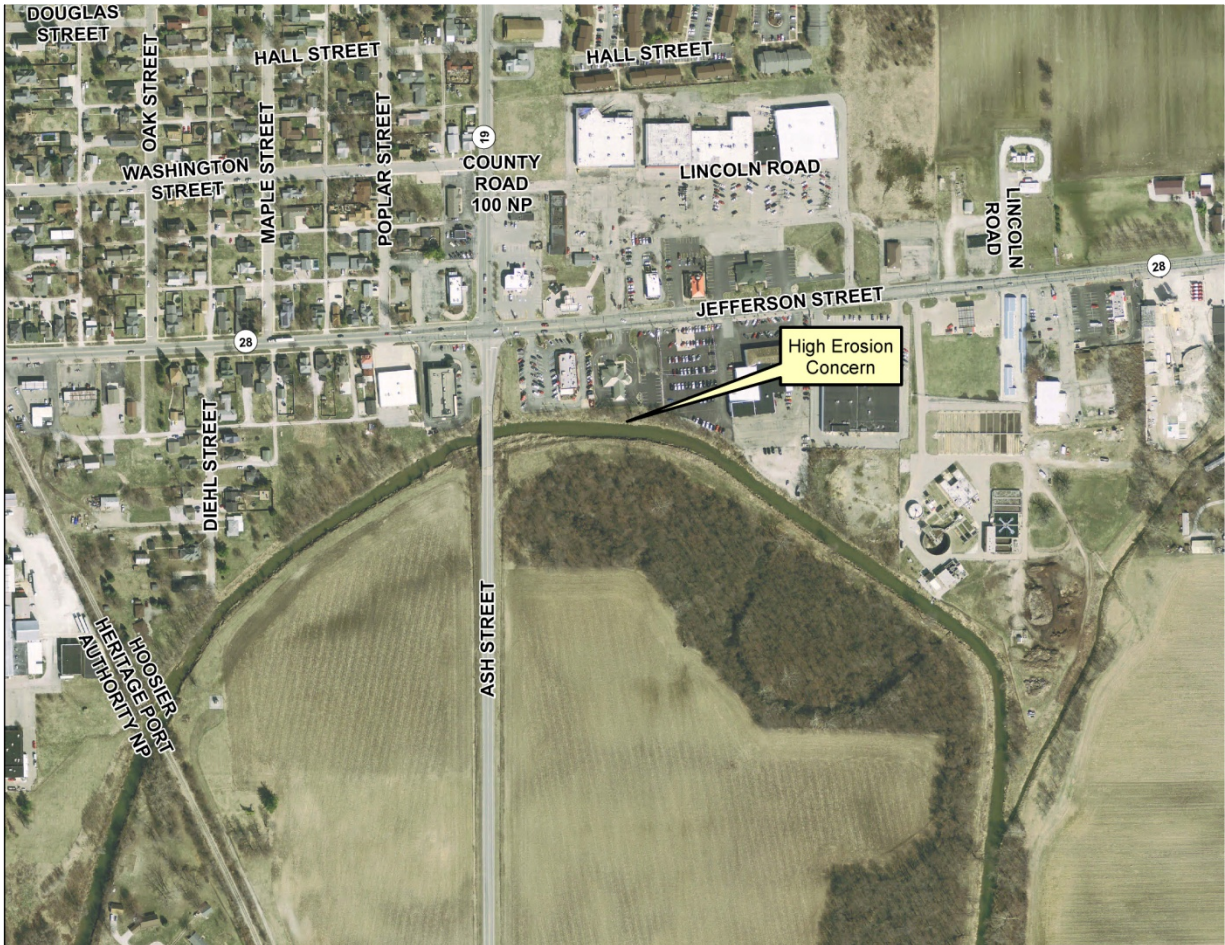
Figure 41. Commercial District Stream Bank

According to Wyatt Henderson, City Engineer, when the channel was dredged at the site, the banks were 10 feet in height and have been altered significantly from erosion. The community has started to discuss mitigation measures to alleviate the erosion hazard.

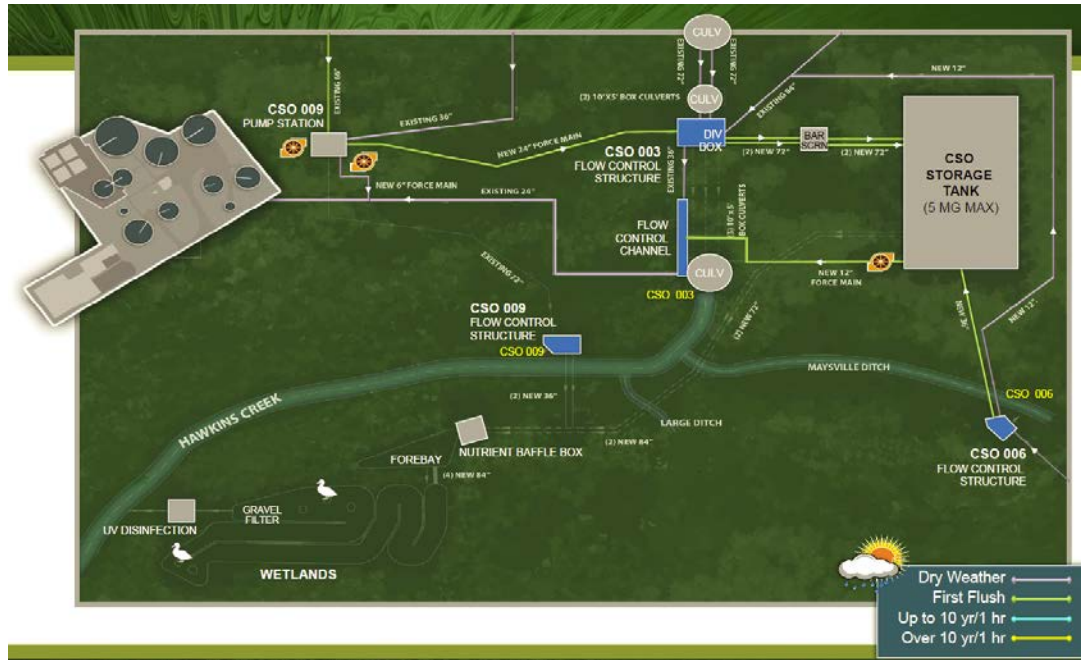
Figure 46. Underground Pipes

An initiative to combat flooding in the City in the early 1990s prompted the burial of portions of Hawkins Creek and an adjacent tributary to Hawkins Creek. The main channel enters the below ground sewers at the golf course and have recently been improved. The tributary to Hawkins Creek enters the below

- Evaluate the function of the entire system including detention basins, underground piping, and control structure, and determine their effects on the hydrology of the creek.
- Ensure there is the proper documentation in place to certify the detention basins as flood control.

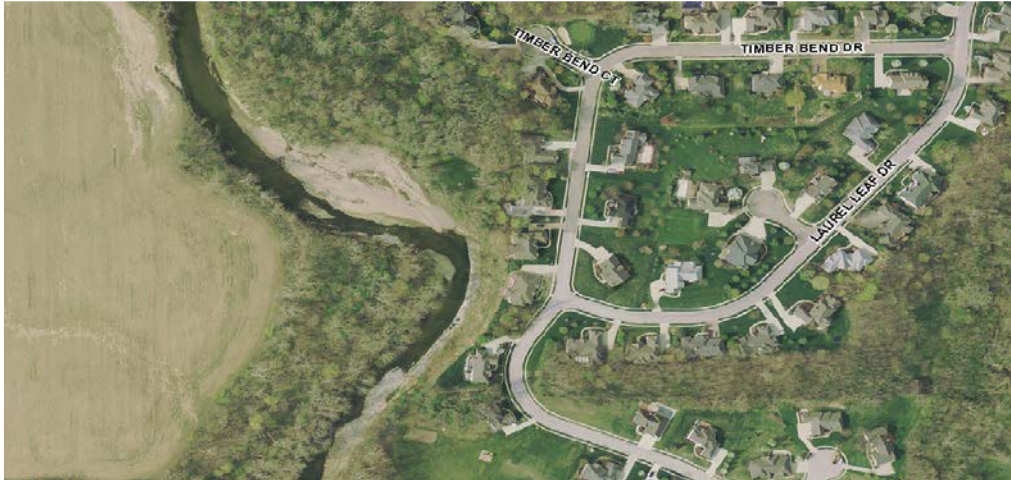
Figure 52. Timber Bend Subdivision

Evidence of the channel migration and erosion issues can be seen in the photos that follow. In the first image, the Timber Bend subdivision is located adjacent to White Lick Creek. The creek channel is migrating east towards the homes along Timber Bend Drive.

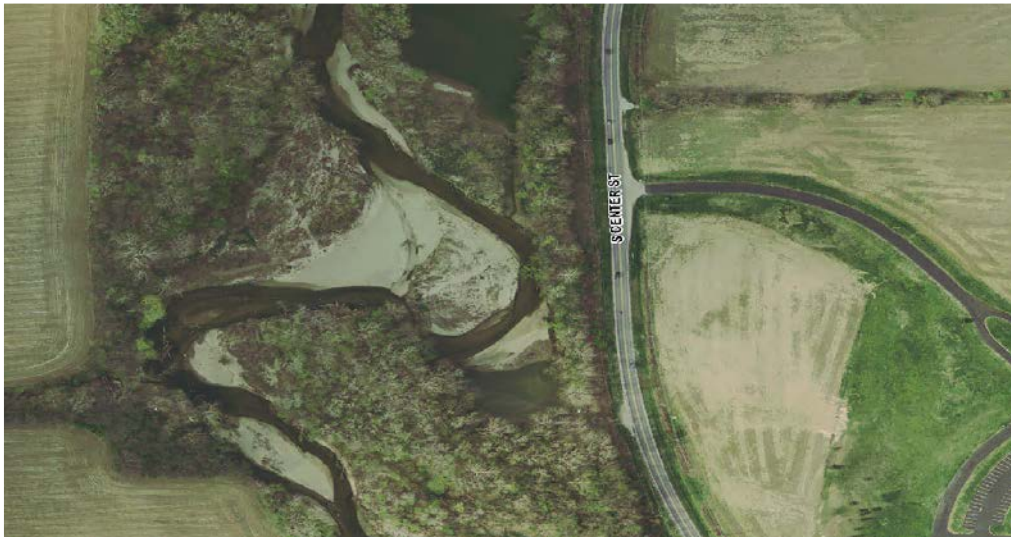
Figure 53. Center Street

In the following image located along White Lick Creek near the town of Plainfield, the channel is migrating towards Center Street. Much of the financial impact of fluvial erosion is due to the interaction of the stream channels with infrastructure. If the movement of this channel is not mitigated, Center Street will be undermined and require repair.

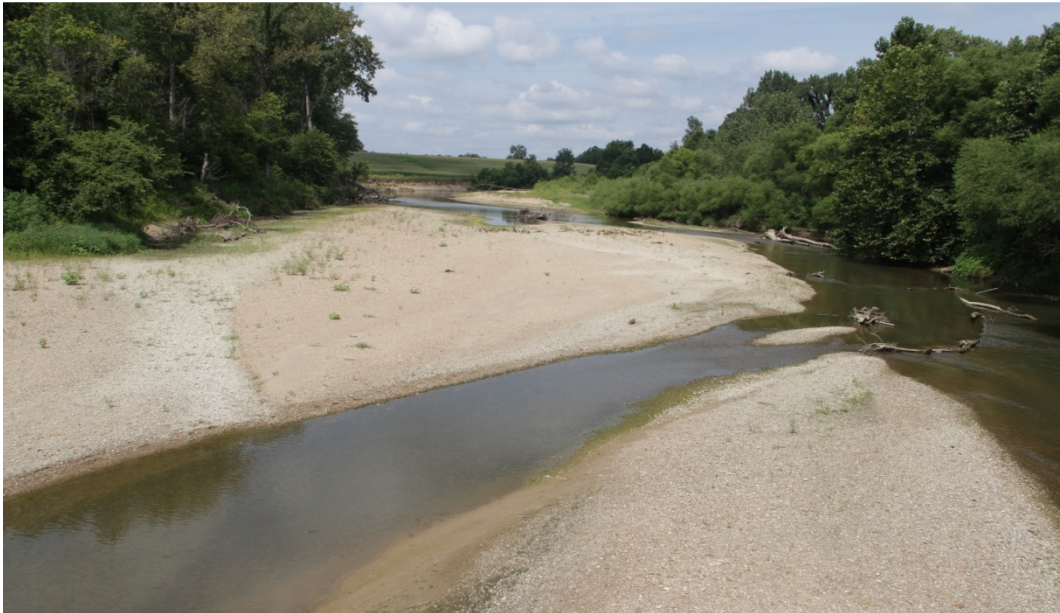
Figure 54. White Lick Creek Point Bar Development

The next photograph, taken by Bret Robinson, USGS, along White Lick Creek, clearly shows an area of significant point bar development. This type of feature is common in streams with high sediment loads and is indicative of active erosion upstream from this site.
